APPENDIX B. MATERIAL AND ENVIRONMENTAL DATA

B.1 MATERIALS TESTS-SUMMARY

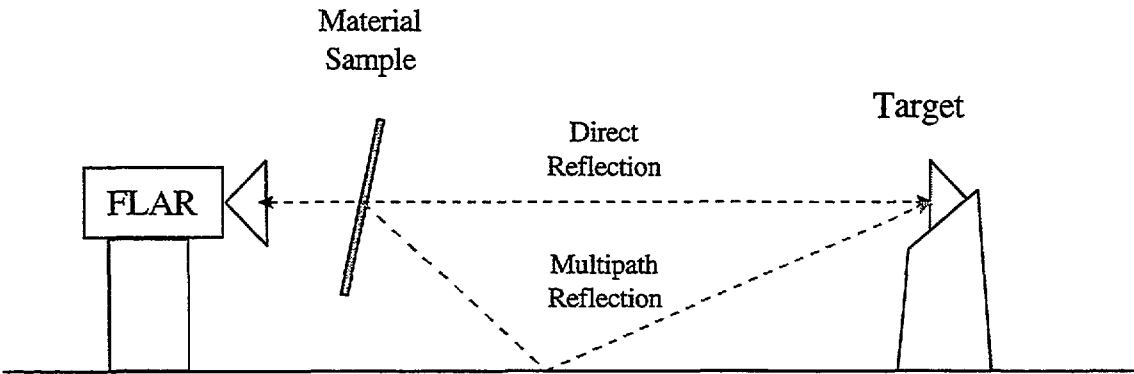
Figure B-4. Multipath Reflection

In addition to the reflections and signal attenuation, several of the material samples were observed to produce multipath returns from the reference reflector. Figure B-4 shows a diagram of how an obstructing material can cause a multipath return. Some level of energy is refracted by the material and directed along an indirect path to the target. Since the distance the radar signal must travel the indirect path is longer than that along the direct path, the resulting range reading from the radar will be greater than the actual direct range to the target.

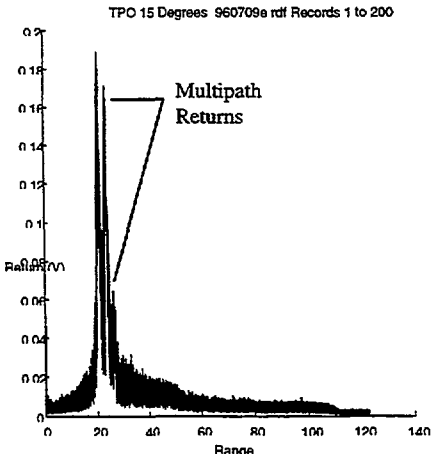
Figure B-5. Multipath Returns From TPO Material at 15 Degree Incident Angle

Figure B-5 shows the radar returns collected with a TPO material sample oriented 15 degrees off vertical. The multipath returns from the reference reflector are clearly evident. These effects were also observed for other materials tested. The effect of this phenomenon is that the peak level return from the reference reflector is decreased and false returns are produced. See the plots attached for more multipath examples.

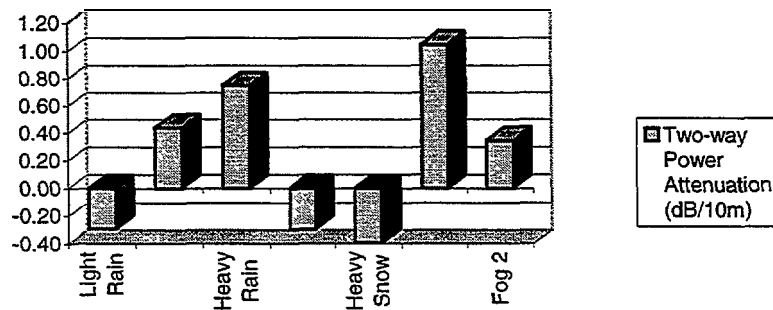
Figure B-10. Two-Way Power Attenuation (dB/10 m)

Figure B-10 illustrates the attenuation levels produced from the various levels and types of precipitation. These attenuation levels have been normalized to 10 meter ranges. These values are considered insignificant since return levels from the FLAR during static collections with precision reference reflectors in a controlled environment have been observed to fluctuate by values similar to these. Note that negative attenuation levels indicate that the peak return from the target in the scene actually increased. This could potentially be due to the target getting wet and causing more of the radar energy to be directed back in the direction of the FLAR or due to the ground between the radar and the target getting wet and causing a higher level of multipath return.

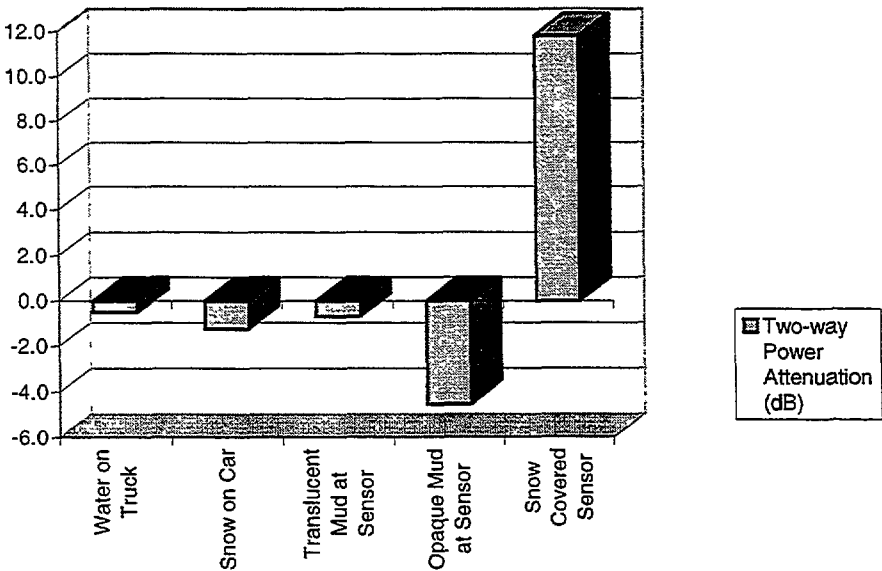
Figure B-11. Two-Way Power Attenuation (dB)

Figure B-11 above illustrates the attenuation levels produced from the various types of contamination. Note that negative attenuation levels indicate that the peak return from the target in the scene actually increased.

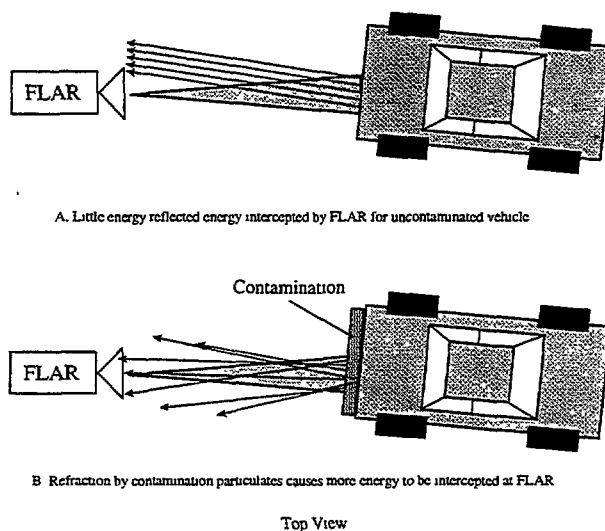
Figure B-12. Potential Cause for Contaminated Target Increased RCS

The contaminated vehicle test results correlate with some of the observations made during the precipitation tests. In these cases, a potential explanation is that the particulate contamination on the vehicle may be enhancing the return level by creating more scattering centers through refraction of the radar energy. Figure B-12 illustrates this concept.

Figure B-12 shows how a contamination layer might cause reflected energy to become more diffused compared to the reflections from an uncontaminated target. While this diffusion process may cause the power density (mW/cm^2) of the reflected wave to decrease, the FLAR still intercepts more power per unit area (i.e., the receive antenna aperture). Note that this explanation is a hypothesis which should be verified through further testing which was beyond the scope of this project.

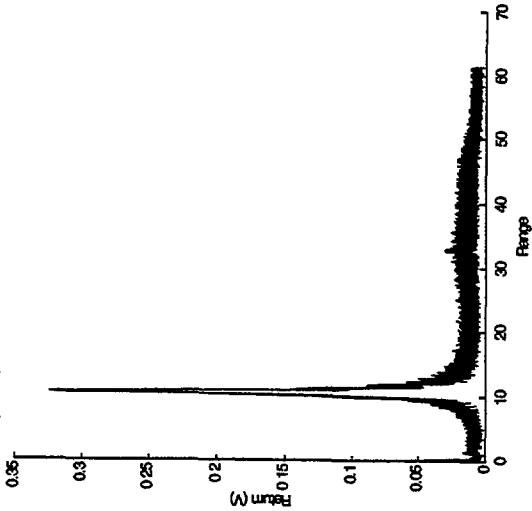
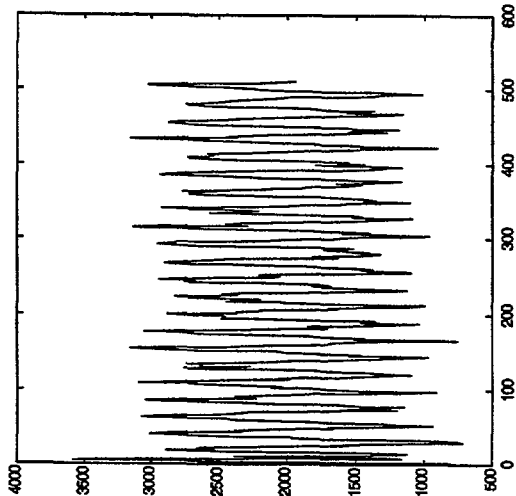
Very Muddy Contamination at Sensor: 960313m.rdf Records 1 to 100

Similar to the contaminated target results were the results from the contaminated sensor testing using semi-dry mud. These tests again resulted in 'negative' attenuation, or an observed gain in peak return level. In analyzing the range profiles for the mud contamination tests, it was observed that the contaminated glass plate itself did NOT reflect energy back to the FLAR. The only difference between the baseline and contamination tests was the peak return level from the reference reflector. A potential cause for this phenomena could be an effect similar to that described above, except that the diffusion of energy occurs at the contaminated glass plate (approximately 1 meter in front of the sensor) rather than at the target. Again, this explanation is a theory requiring more stringent contamination testing for verification.
